Infrared Spectroscopy

PerkinElmer, Inc.
Waltham, MA

Industrial Equipment Failure Analysis Using FT-IR Microscopic Techniques

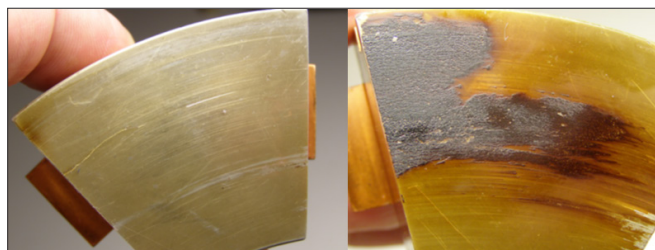
Kingsbury bearings surround a shaft with several interlocking shoes which float on a hydrodynamic layer of lubricant flowing across the bearing surfaces. Figure 2 shows a clean bearing shoe compared to the failed shoe (with visible varnish deposition and wear present). To gain further insight as to how the deposits formed, FT-IR microscopy analysis was carried out on the surface species present on the sample.

Figure 2. Clean Kingsbury bearing shoe compared to failed shoe.

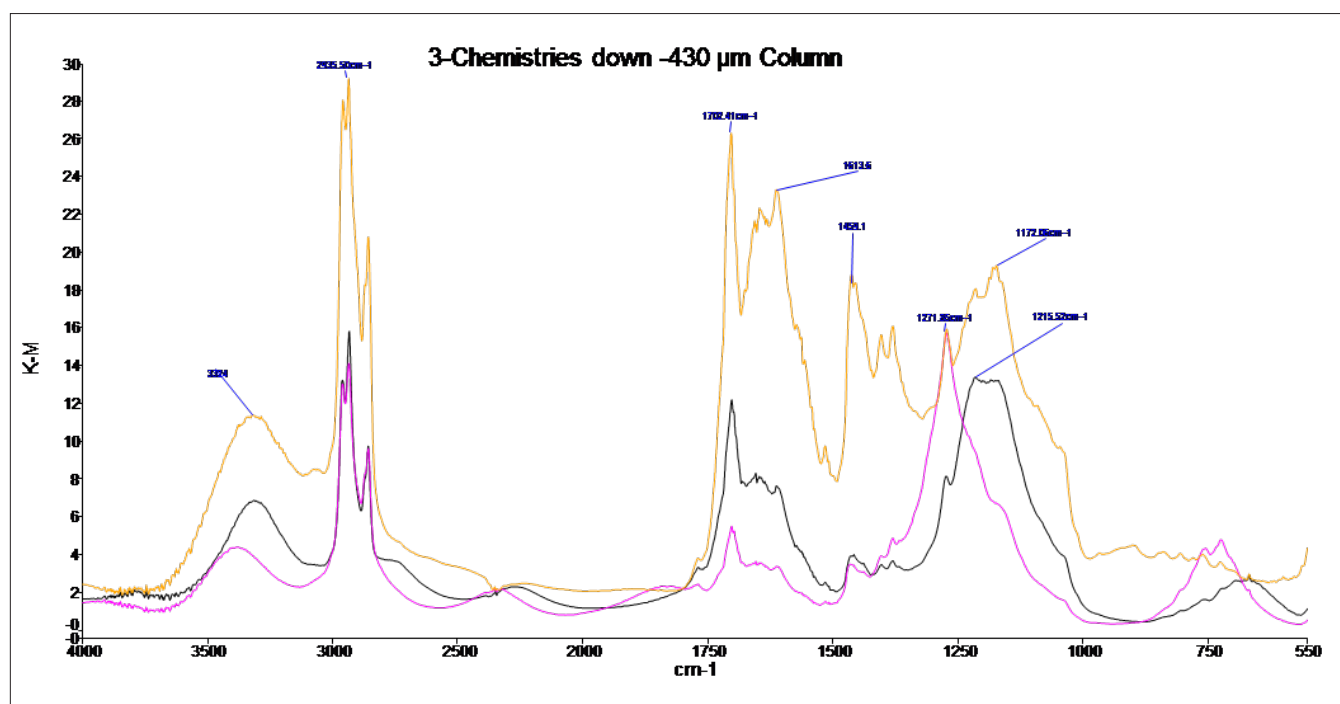
Once the map scan has been collected, an FT-IR spectrum can be viewed from any point on the map in order to show the change of chemistry across different sections. Figure 3 shows a spectral overlay from three different points. Analysis of the resulting spectra reveal hydroxyl group, thermal-decomposition and oxidation increases of the fluid as well as deposition of the phosphate anti-wear additive.

Figure 3. Spectral overlay of three different points on map scan of Kingsbury bearing.

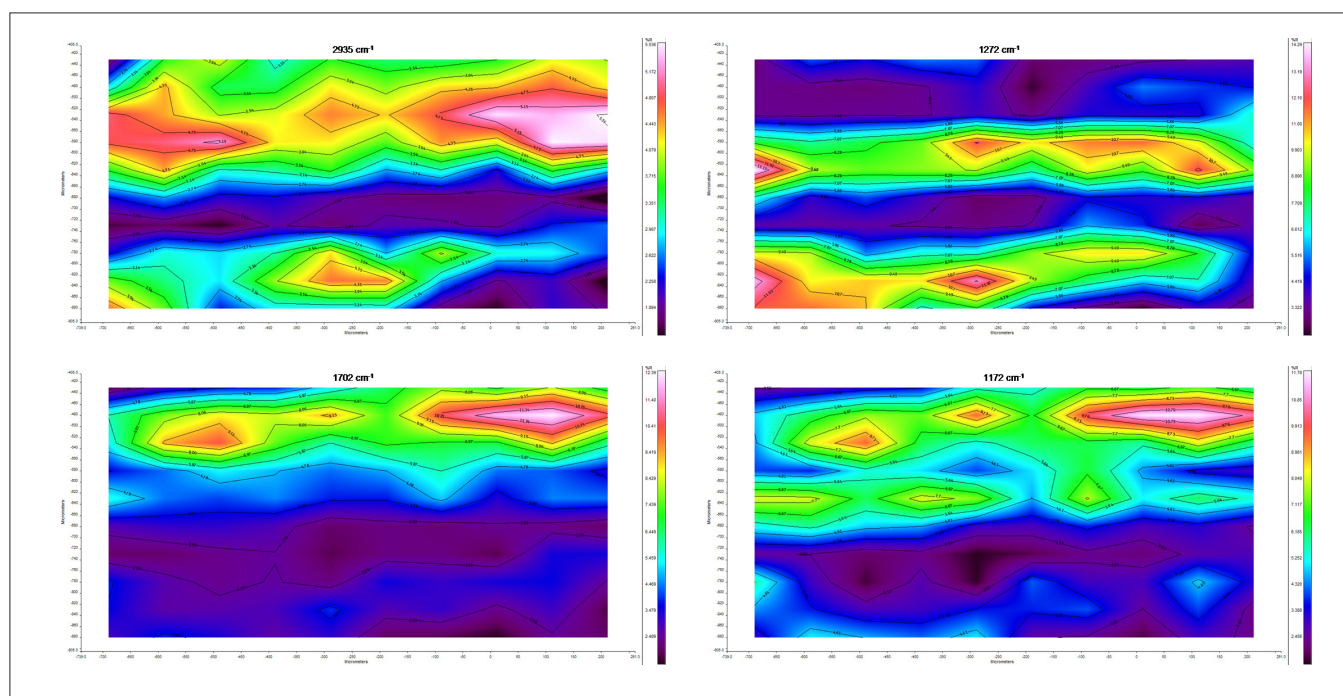
Furthermore, total absorbance plots at individual wavenumber values can be prepared to see high and low concentrations of individual chemical species on the surface of the sample. Figure 4 illustrates four color images of the surface at different wavenumbers showing how the chemistries are not evenly distributed across the surface.

In this example we showed that FT-IR microscopy analysis was able to elucidate the cause of the surface species on the Kingsbury bearing to be determined, reflected by the non-homogeneity in surface chemistry. Consequently, understanding these surface deposits allows actionable measures to be implemented to prevent this recurrence on other equipment.

Figure 4. False color images of surface of Kingsbury bearing at different wavenumbers.

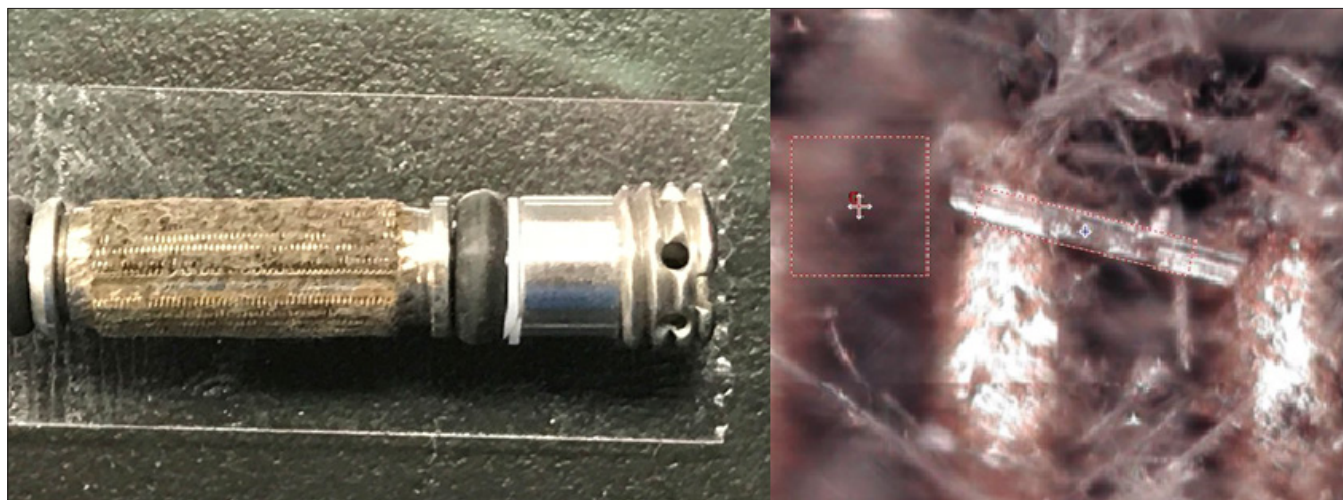
Figure 5. Failed in-line actuator filter on microscope plate (left) and collected visible image (right).

The resultant spectrum was identified as fiberglass. There are other filters in the system made from fiberglass material and, as such, it can be proposed there is a problem upstream with another filter.

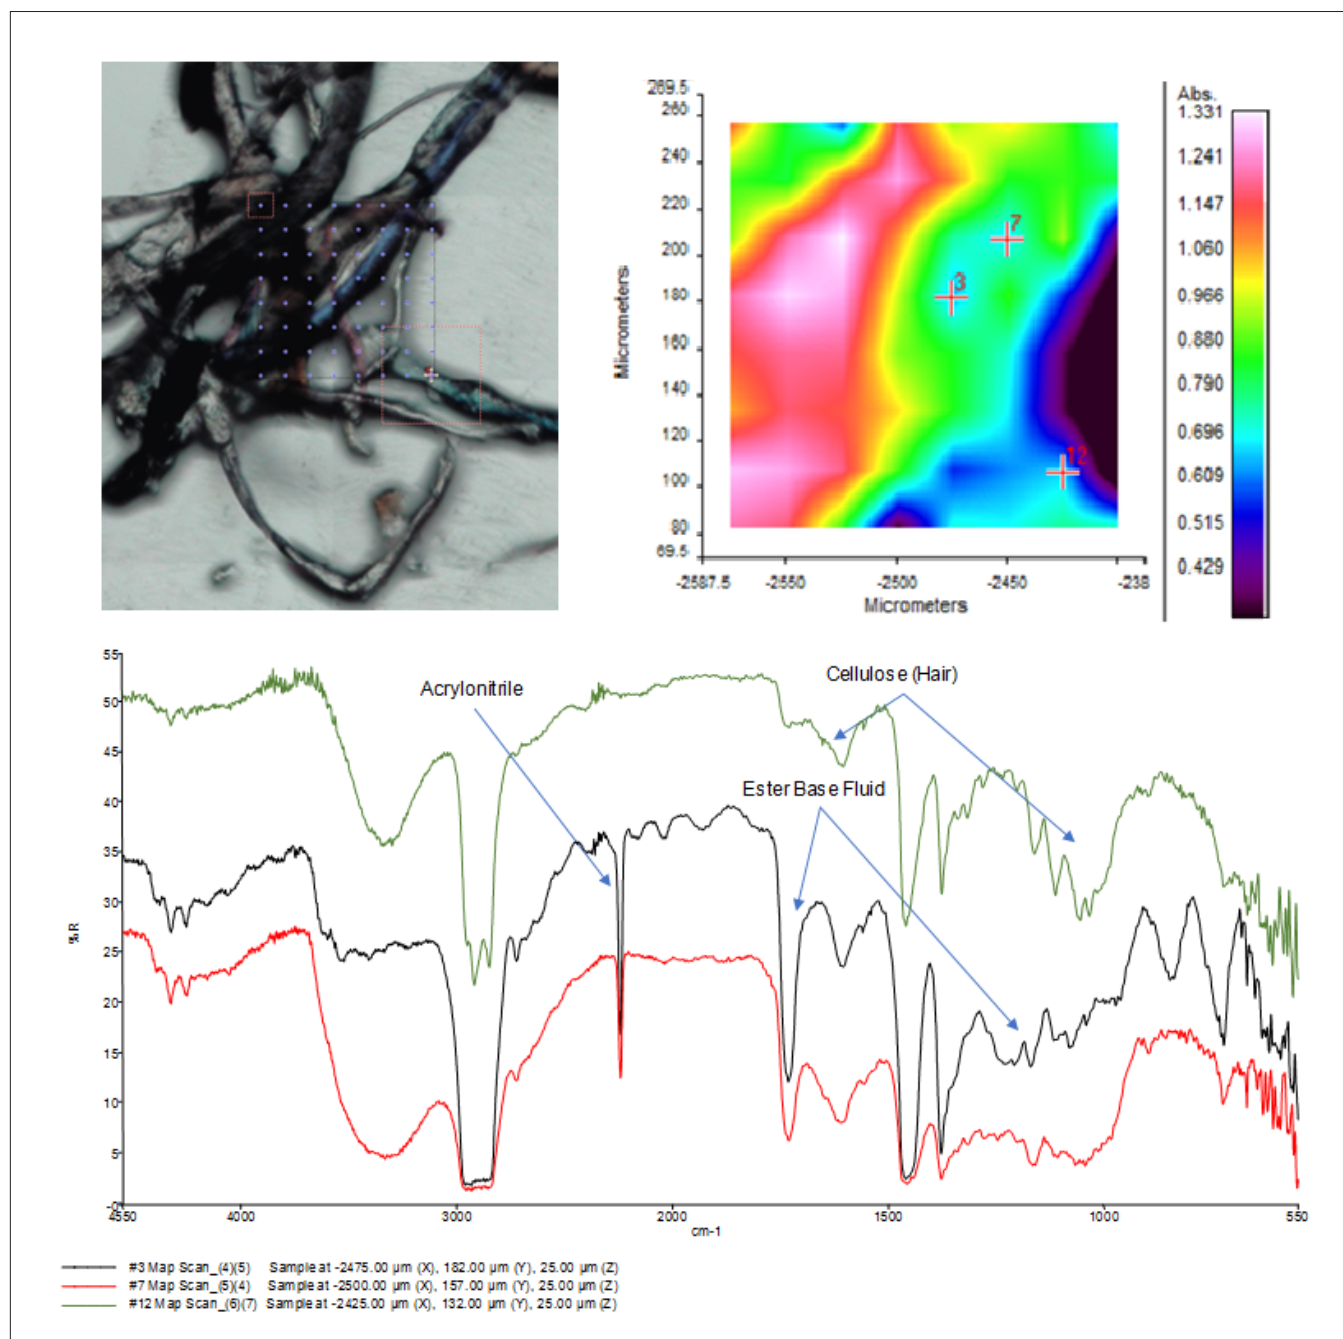
In a separate case study, a system was having actuator plugging with poor fluid flow and it was believed to be due to a broken filter. Similar to the previous example, FT-IR microscopy was used to analyze individual fibers on the surface of the filter. The collected spectra showed the unexpected presence of C≡N (nitrile) and NH₂

Spectra from different points of the map scan were analyzed and it was determined that some of the contaminating fibers were hair. Furthermore, some of the mass containing CN vibrations was found to be from acrylonitrile o-rings.

Figure 6. Visible image of extracted fibers (top left), color image of map scan (top right) and spectra from three points of map scan (bottom).

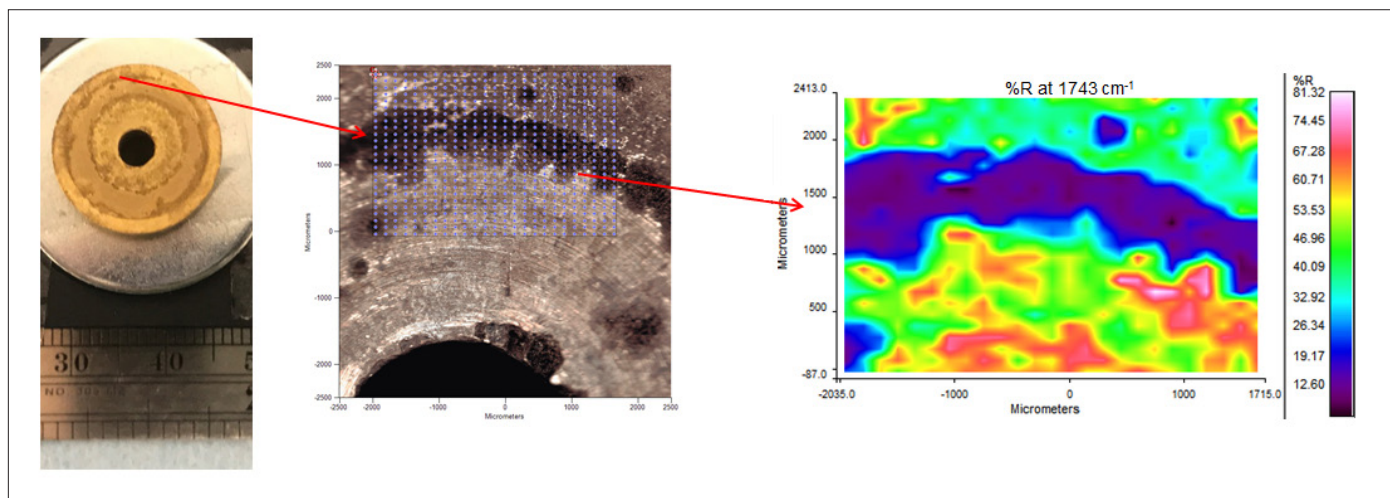
The hydraulic control valve, shown in Figure 7, malfunctioned due to the observed corrosion of the brass surface resulting in fluid leakage. FT-IR microscopy can be used to determine how the pits and deposits on the surface of the valve were formed.

Figure 7. Failed hydraulic control valve (left), collected visible image (middle) and color image at 1743 cm^{-1} (right).

Studying the spectra within the corrosion pits allowed one to determine that this system was using a vegetable oil based hydraulic fluid that was inappropriate for the specific application. Heat, water and copper from the brass valve caused oxidation reactions to occur resulting in the formation of acids. The acids then reacted with the surface of the valve, causing it to corrode; leaving the resultant acid salts in the reacted holes. Determining the cause of the valve surface corrosion allowed the system reliability and efficiency to be improved by changing to a different hydraulic fluid.
